*Encasement:
Safeguarding People
While Saving™*

ENCASEMENT OF INSULATION IN FRESH AIR PLENUMS Midwest Location CH-98-1

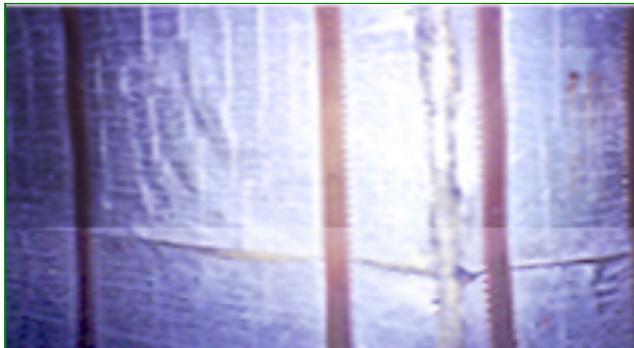
BEFORE

PROBLEM: Two large fresh air plenums were partially lined with foil-covered fiberglass insulation that was in fair-to-poor condition. The insulation, which totaled approximately 13,000 sq. ft., was also contaminated with molds, thereby contributing to a potentially serious Indoor Air Quality (IAQ) problem.

SOLUTION: Installation of a Safe Encasement System was considered and a test patch provided the owner with the confidence to encase all of the insulation. Where torn or missing fiberglass insulation was found, repairs and replacement took place. The metal hold-down straps were re-secured where necessary. Bleach was spray applied to the insulation at the outset. A light coat of corrosion-inhibited primer was sprayed onto the metal hold-down straps. Then a 16-wet mil coat of SE-110 Penetrating-Stabilizer (primer) was sprayed over the entire surface and allowed to dry. A 4-inch wide polyester scrim fabric dipped in the primer was applied over all outside corners. A 4-inch wide butyl seam tape with a penetrable fabric backing was applied over all seams and over the hold-down straps, bridging from insulation sheet to insulation sheet. A small amount of additional primer was then applied over the tape. Then 16 wet mils of SE-120 Protective-Skin topcoat was spray-applied over the entire surface. The combined coatings provide a tough monolithic coating system with outstanding adhesion. To improve the wash ability of the system a few mils of SE-170 high-gloss topcoat was finally applied over the entire system. The total cost of the system, including the use of over two miles of tape and the application of the third coat was less than half of the cost of removal and replacement, and that included the cost of scaffolding rental. The owner now has a washable system that should last for at least 20 years.
