ENCASEMENT OF ASBESTOS CONTAINING TEXTURED CEILING IN DORMATORY STAIRWELL

University of North Dakota
Grand Forks, ND

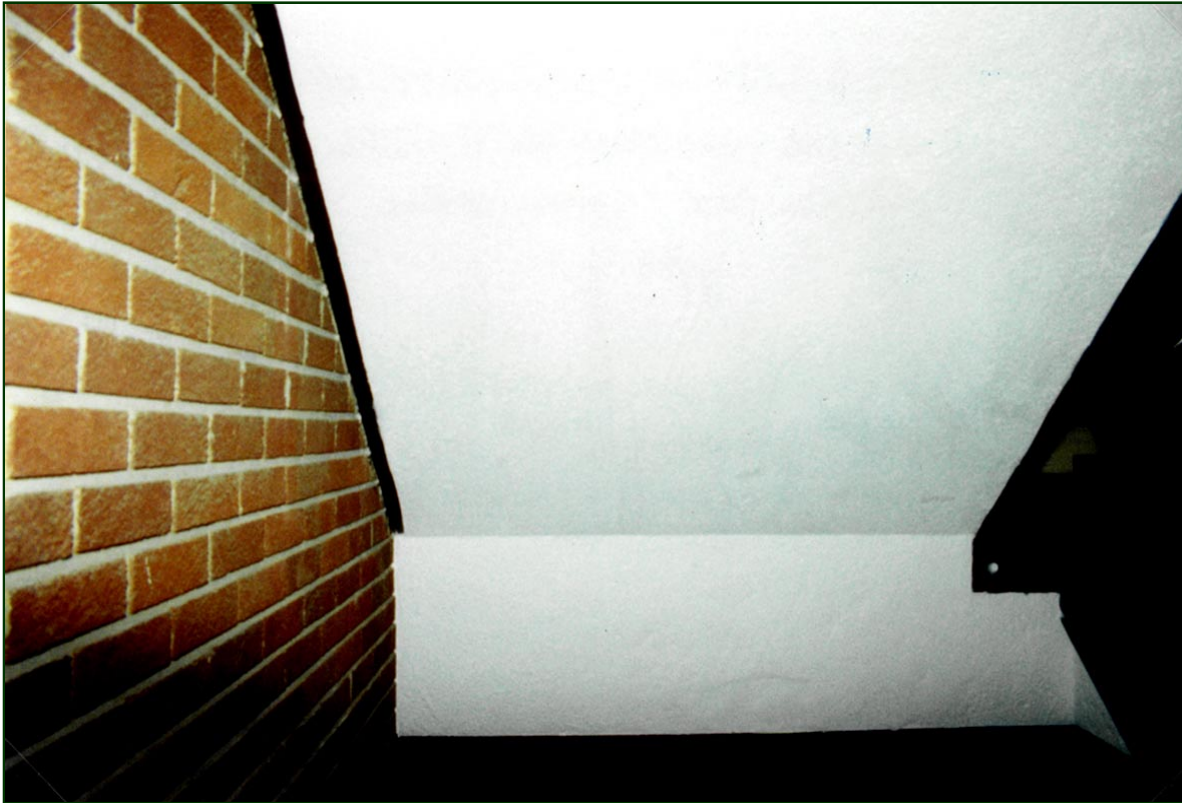
Challenge: A portion of the textured acoustical ceiling in the stairwell of a dormitory at the University of North Dakota had become damaged to the point where the asbestos containing texture along with lead-based paint on the surface of the textured ceiling, was crumbling off onto the stairs below. Removal and replacement of the textured ceiling was considered prohibitively expensive (\$7-11 per square foot).

Solution: A decision was made to use encasement to eliminate this hazard. SE-110 Penetrating-Stabilizer (primer) was first applied onto the entire stairwell ceiling to stabilize this surface. Next, the damaged areas (with visible profile differences) were built up with SE-150 architectural sealant, after which the entire stairwell ceiling was sprayed with SE-120 Protective-Skin topcoat. Finally, to make the patched area less conspicuous, some grit was added to a quart of SE-120 topcoat that was then brushed over the patched areas to create a textured appearance.
