Abatement by Encasement:
Safeguarding People
while Saving Money ®

ENCASEMENT OF LEAD-BASED PAINT ON STUCCO HOUSE CH-03-3

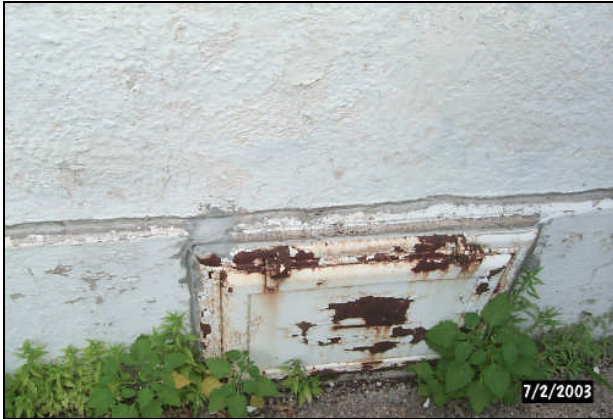
BEFORE

CHALLENGE: An 80-year old stucco home was coated with badly peeling lead-based paint. Because of the location of the home at the junction of two busy downtown streets and the fact that there was little land on the side of the house facing one of the streets, the options for surface preparation were limited. Power-washing was ruled out because of the difficulty of collecting and containing the wash water. There were numerous areas where the stucco was cracked or otherwise damaged.

SOLUTION: The surface of the stucco was hand scrubbed with a 4-5 % solution of Chlor*Rid to remove the loose, flaking paint and eliminate any efflorescence. The primary use of Chlor*Rid is to remove corrosion-causing soluble salts on metal surfaces before they are coated, but it has also been shown to facilitate the removal of efflorescence. The surfaces were then stabilized by spray-applying approximately 10 wet mils of SE-110 Penetrating-Stabilizer (primer). The shrinkage of the primer as it dried caused some of the remaining paint to lift in a few areas, which was rectified by a unique application of caulk that was worked in by the workers wearing latex gloves. Cracks were then filled using the same urethane-acrylic caulk, followed by the spray-application of approximately 10 wet mils of SE-120 Protective-Skin (topcoat) that had been pigmented to achieve the desired color.
