STABILIZATION OF LEAD-BASED PAINT ON STEELWORK OF DESOTO BRIDGE IN ST. CLOUD, MN PRIOR TO DEMOLITION

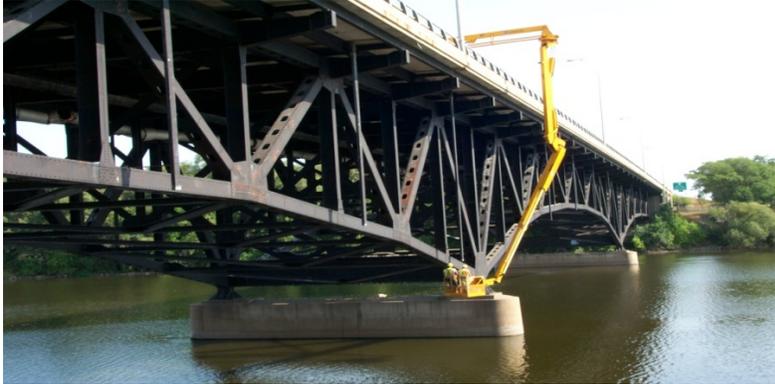
DESOTO BRIDGE IN ST. CLOUD, MN

The Desoto Bridge over the Mississippi River in St. Cloud, similar in vintage and design to the ill-fated I-35W bridge in Minneapolis and, like so many other older bridges across the country, was found during a March 2008 inspection to be in badly deteriorating condition and in need of major repair or replacement. The inspection revealed extensive corrosion and bending of gusset plates in 4 locations, leading to a replacement decision. MNDOT plans to replace over 60 bridges by the end of 2012.

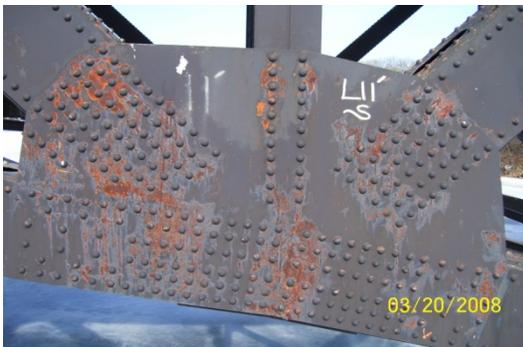
CLOSEUP OF GUSSET PLATE
