Abatement by Encasement:
Safeguarding People while
Saving MoneySM.

ENCASEMENT OF LEAD-BASED PAINT OVER GALVANIZED DECORATIVE TRIM Minnesota High School

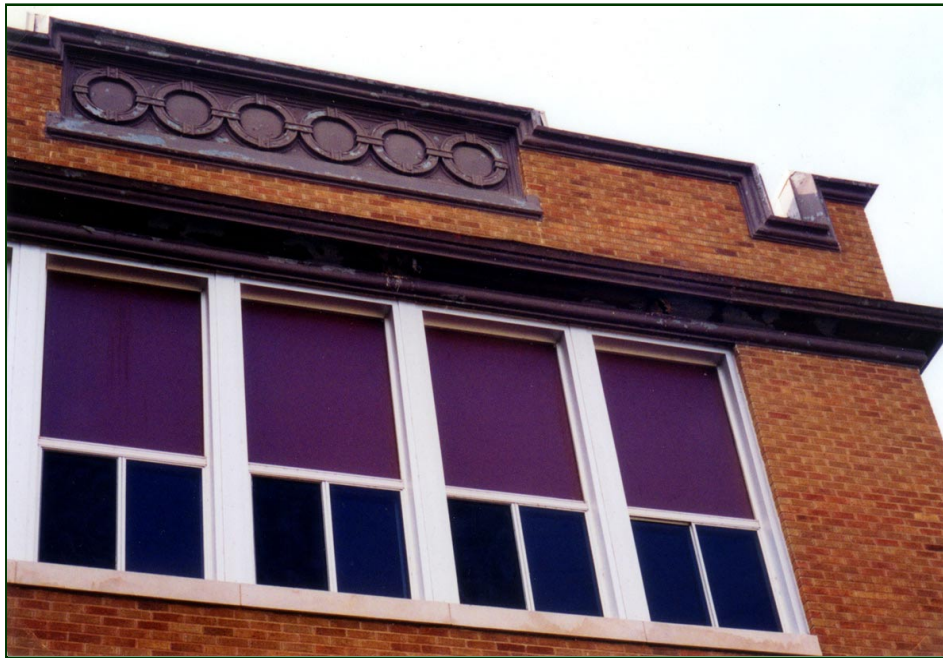
👉 **Before** - the deteriorated condition of the trim detracted from the appearance of the building.

Challenge: Galvanized metal decorative trim, flashing and roof top ventilators on this 1920's era Greenway High School in Coleraine, MN were coated with multiple layers of flaking Lead-Based Paint (LBP). Complete removal of the paint on the flashing and trim near the top of the wall was considered impractical and would be very costly. It would have required complete containment and would have required several weeks for removal of the paint from approximately 8,000 sq. ft. of surfaces, much of which consisted of intricate patterns and contours. There were also scattered rusting areas on this old galvanized metal.

Solution: The solution chosen was removal of only the very loose, flaking paint – followed by stabilization of the surfaces with a proprietary primer from SAFE Encasement Systems, SE-110-CI which contains a highly effective corrosion inhibitor. Following the removal of the damaged paint, 16-18 wet mils of the SE-110-CI was spray applied. This primer penetrated the old LBP, re-adhering any loose paint while rendering it non-friable. Custom tinted SE-120 was then spray applied over the primer at 16-18 wet mils completing the encasement process. This composite system provides a tough monolithic, flexible protective barrier that will not crack or peel, and provides lasting, long-term protection against the release of lead paint into the environment.

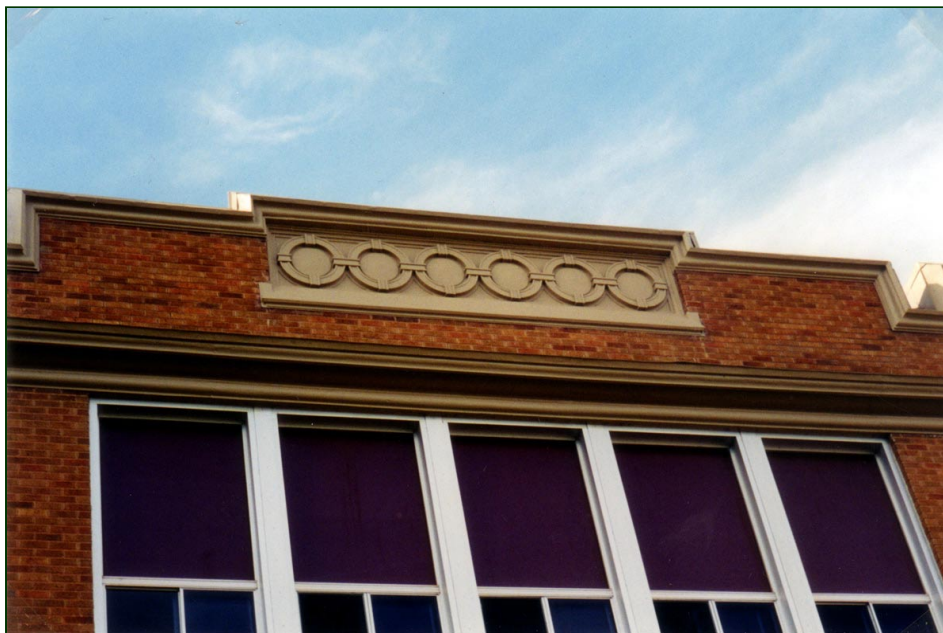
👉 **After** - encasement abated the concerns about LBP while improving the appearance of the building.
