Abatement by Encasement:  
Safeguarding People  
while Saving Money<sup>SM</sup>.

## FLAKING PAINT ON TRUSSES IN NORTH DAKOTA YOUTH CORRECTIONAL CENTER

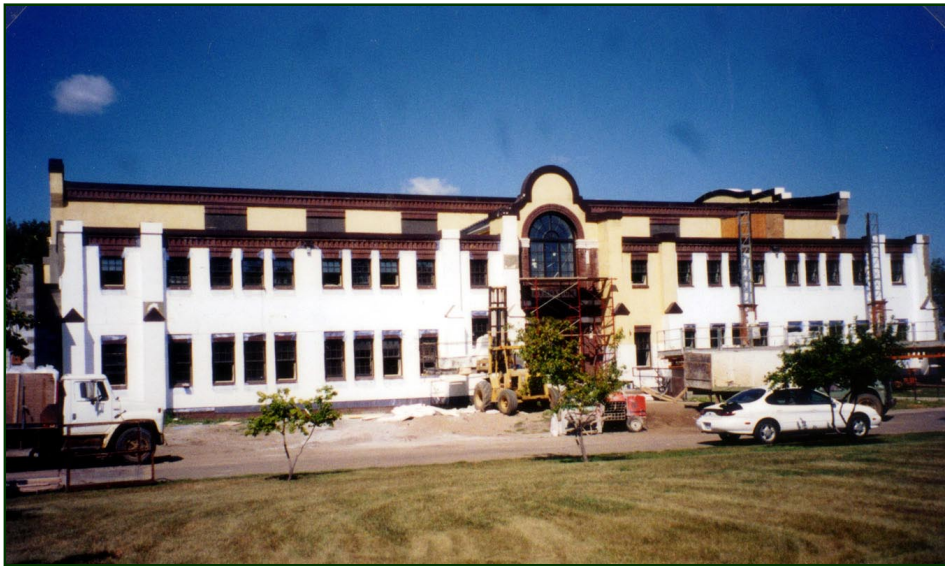
**Challenge:** The trusses in the gymnasium at the North Dakota Youth Correction Center in Mandan, ND were covered with extensive loose flaking paint, were to be repainted as part of a major renovation project. Although Lead-Based Paint (LBP) was not involved in this case, extensive surface preparation (removal) would have been required if a conventional paint had been used to re-paint these trusses.

**Solution:** The solution chosen was the use of SAFE Encasement Systems proprietary coating system that requires minimal surface preparation. Only the really loose, flaking paint was removed prior to starting the encasement process. Then SE-110 Penetrating-Stabilizer (primer) was spray applied to achieve a wet film thickness of 16-18 mils (7-8 dry mils). The SE-110 penetrates the existing paint, re-adhering any remaining loose and flaking paint, and renders it non-friable. Not only is outstanding adhesion achieved on all surfaces, but also the penetration ability of the primer into difficult spaces between back-to-back angles allows the primer to stabilize the loose paint in those spaces. The primer is next over-coated with SE-120 topcoat, which is spray applied to produce a wet film thickness of 16-18 mils (dry film thickness 10-11 mils). In a case like this the "shrink-wrap" effect of this encasement system around the truss members provides additional assurance that the coating system will remain in place for many years. In situations such as this, the reduction in required surface preparation leads to substantial labor and time savings.
