ENCASEMENT OF LBP-COATED, RUSTY STEEL BEAMS in TUNNEL at UNION STATION Denver, CO

01-5

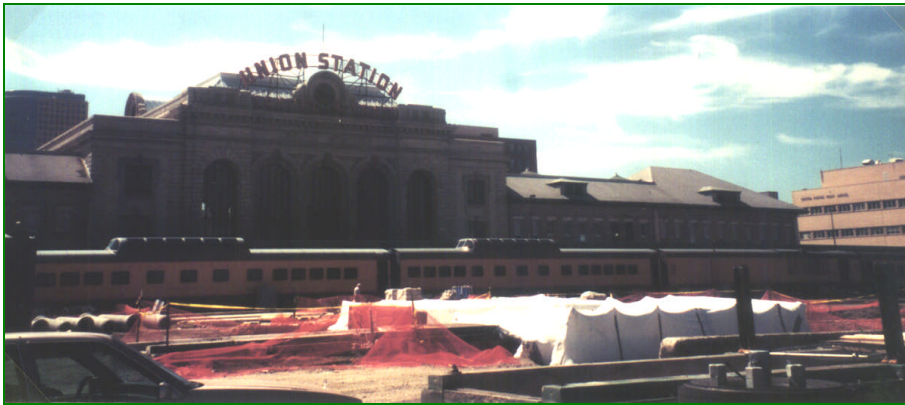
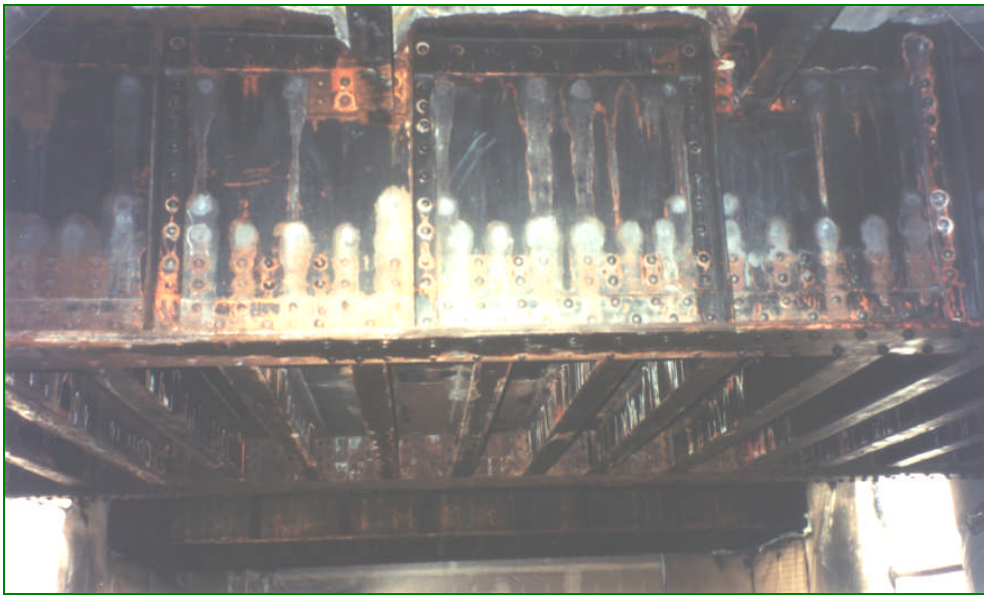
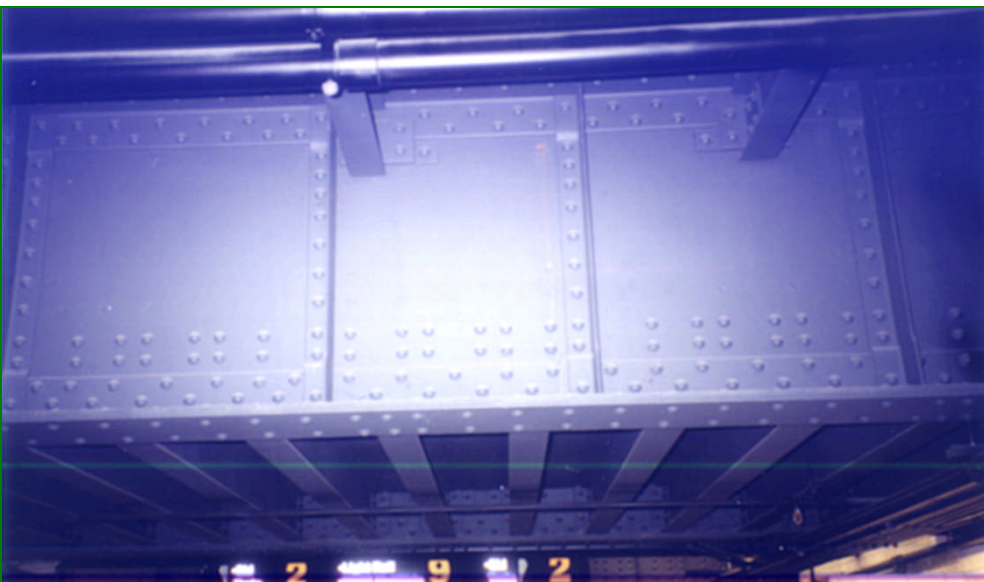
Challenge: An idle passenger tunnel was to be renovated for use in conjunction with the installation of new tracks for the Denver Rapid Transit System. The beams in the roof of the tunnel, over which the new rails will pass, were covered with loose, flaking Lead-Based Paint and a considerable amount of rust. Sandblasting followed by re-painting was rejected because of the costs associated with disturbing LBP.

Solution: The solution chosen was encasement, where a surface-stabilizing primer, followed by an encapsulant top coat is employed. The first step consisted of removal of only the very loose, flaking paint by power washing. Bolt holes were repaired with a non-shrinking grout, following which the beams were brush washed with a solution of 4% Chlor*Rid Soluble Salt Remover in water. Corrosion-Inhibiting primer, SE-110-CI, was then spray applied over all of the exposed surfaces in one day, application rate was 10-12 wet mils. On the following day, pigmented SE-120 topcoat was spray applied to the same thickness. This provides a tough, long-lasting, flexible protective barrier that prevents against the release of LBP and provides protection against future corrosion, and will not crack, chip or peel. *The use of encasement vs. removal saved over 50% of the total cost of abatement.*
