Abatement by
Encasement:
Safeguarding People
while Saving Money SM.

MIDWEST FOOD FACILITY ENCASEMENT CH 01-7

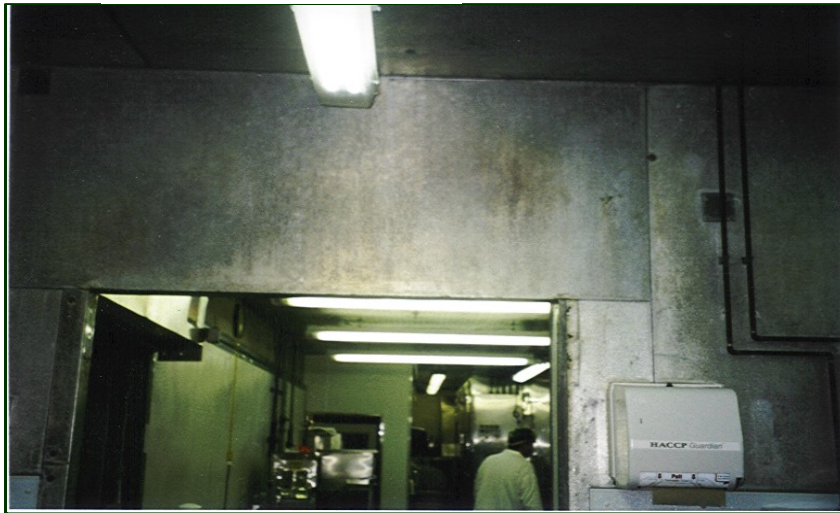
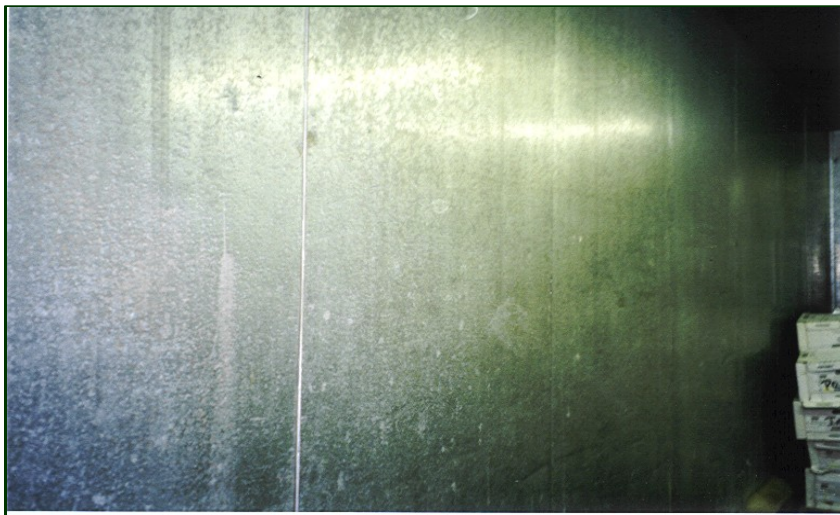
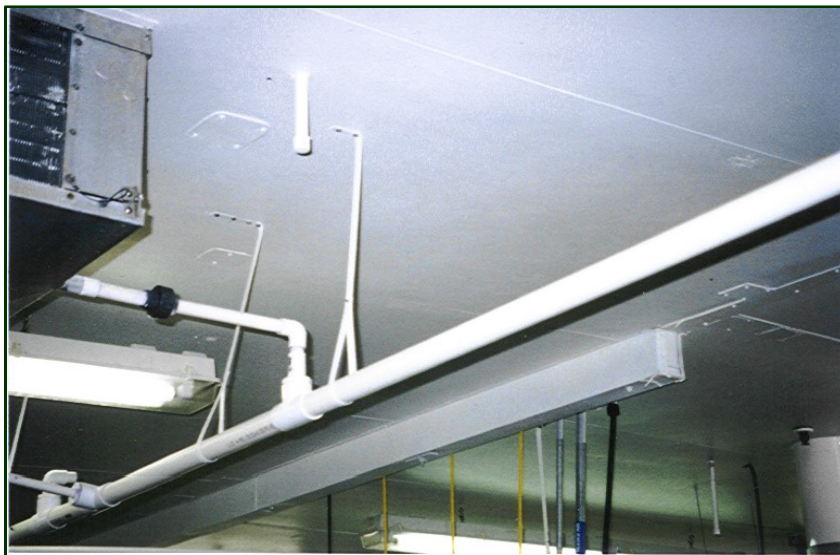
Challenge: This extremely busy Midwest meat cutting and packaging facility had issues with the USDA relative to the condition of the walls, and their ability to clean them to the satisfaction of the USDA. The walls were a galvanized metal plate surface, approximately 1/16th of an inch in thickness. Replacement options were too expensive for both time constraints on this busy facility, and the cost of this option. Doing nothing was not an option due to the decreasing ability to properly clean this surface now visible corroded by the cleaning chemicals required in a food related plant. Attempts at applying various types of coatings led to failures due to inadequate adhesion.

Solution: Encasement was chosen based on its environmentally friendly make up, ability to stick to this difficult surface, compatibility with the short time frame allowed for work, and overall project cost. First all surfaces were power washed with a 2% solution of Chlor*Rid soluble salt remover in water. C*R helps to remove the salts such as NaCl left by the sanitizing chemicals, which catalyze the corrosion reaction. Then SE-110 CI spray applied at 10 wft. A small amount of SE-151 caulk was used where corrosion had left holes. Then SE-120 was spray applied at
