Abatement by Encasement:
Safeguarding People
while Saving Money ®

MOLD IN NEWLY CONSTRUCTED COLORADO HOMES

CH-03-02

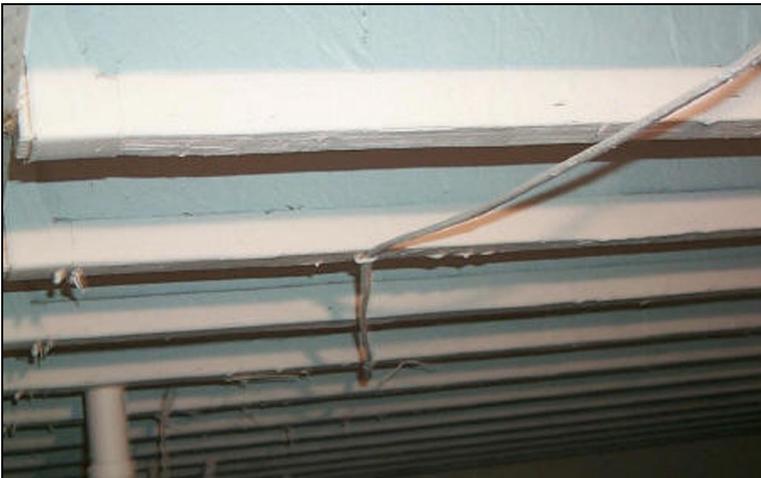
THE PROBLEM: New homes in the Denver area are experiencing visible mold infestations in crawl spaces within the first year or less – before the homes are even occupied in some cases. In an effort to reduce problems associated with slab-on-grade construction in areas with expansive clays, structured basement floors are being constructed. After construction these floors leave crawl spaces 2 to 3 feet above the natural ground. During over-lot grading on new subdivisions mold spores are released into the atmospheres. Due to the rapid rate of house construction and new air-tight construction techniques these mold spores are enclosed within these crawl spaces, which provide a perfect breeding ground for mold reproduction – moisture, darkness and food. Dehumidifying exhaust fans are being installed to alleviate the moisture in the air within the crawl spaces, but once the mold is established dehumidifiers cannot halt the growth of existing mold. Thousands of homes in the Denver metro area are experiencing this rampant problem. Remediation is the only safe course of action.

THE SOLUTION: Following the cleaning and sanitizing of all infested surfaces, with care being exercised to use mildewcides containing low levels of halogens, SE-110-CI corrosion-inhibiting primer (which provide long-term protection against corrosion of hangers and metal fasteners) followed by SE-120 topcoat were installed on the underneath side of the structured floors. This SAFE Encasement coating system prevents the escape of any remaining mold spores, functions as a water vapor retarder that minimizes the amount of moisture that can reach the substrate surface and lead to the re-growth of the existing mold, and it provides an ASTM-tested high level of mold resistance at the surface of the coating that protects against the growth of new mold, all in a tough, flexible, long-lasting protective film with outstanding adhesion to most surfaces. The materials cost of this long-lasting, pesticide-free, mold-resistant coating system is 60-70 cents per sq. ft. The application of this coating system to new construction at the outset provides long-lasting protection from mold development for a cost (including labor) that will be less than 1 percent of the total cost of the home in most cases.
